***2010 Addendum to***  
**2007 Angora Wildfire Hydrophobicity Field Monitoring Report**  
**Lake Tahoe Basin Management Unit**

December 2010

Authored by Sarah Howell, Hydrologist, Tim Tolley, Hydrologist,  
and Sue Norman, Hydrologist

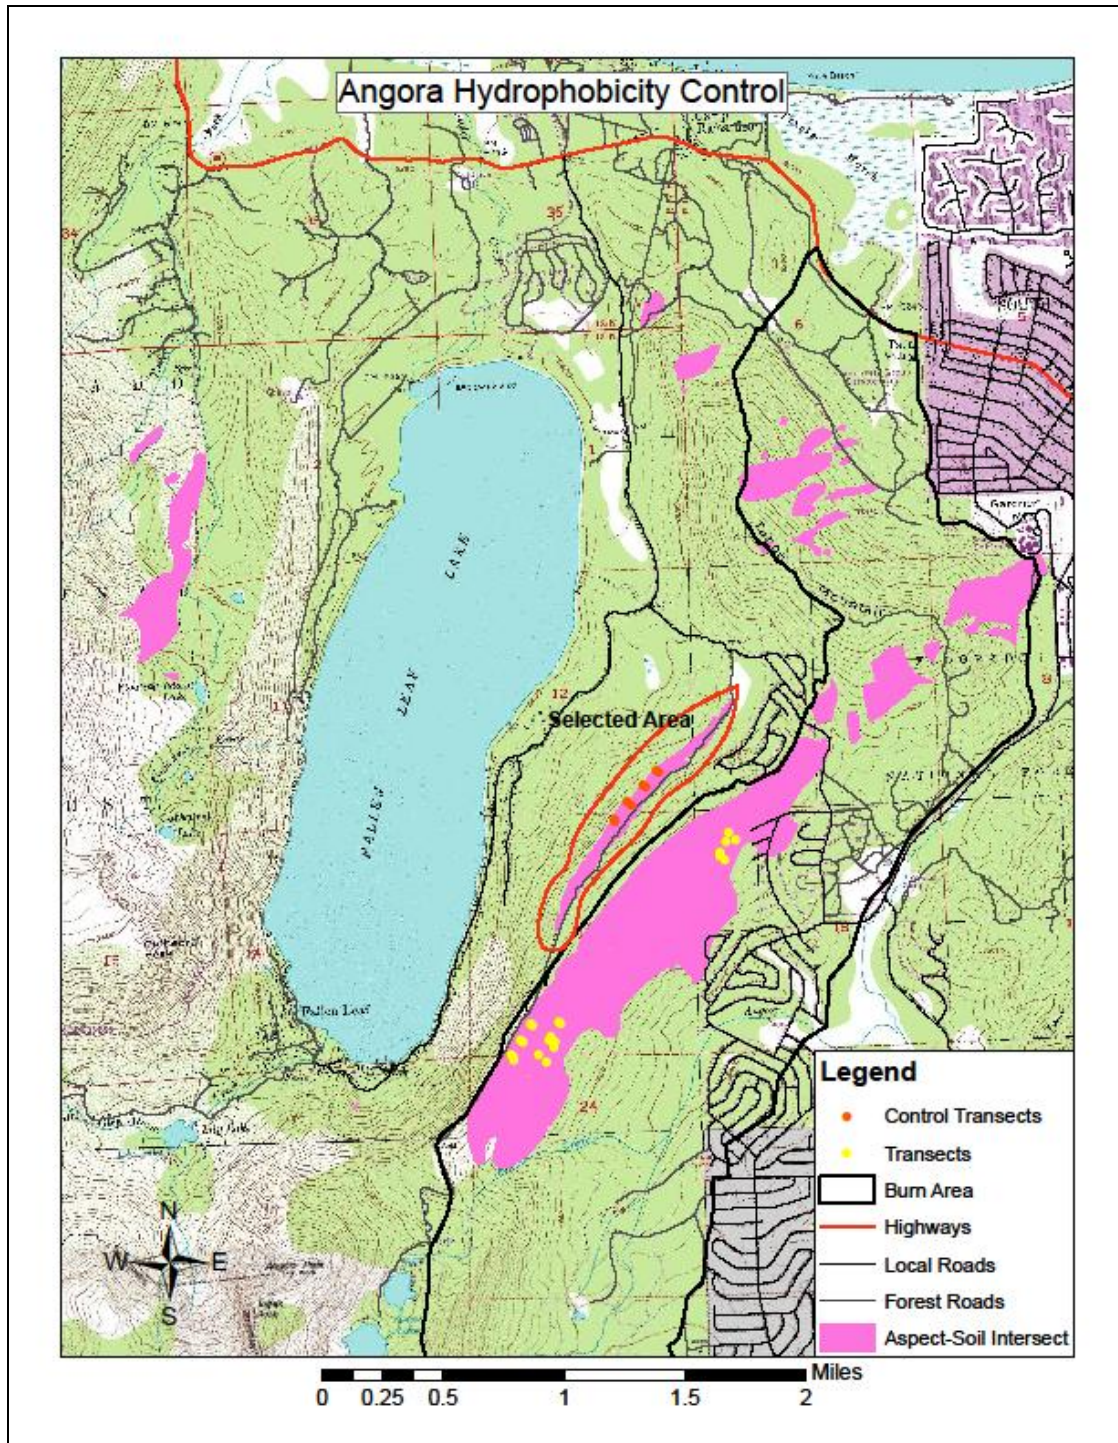
A model was created in ArcMap with these criteria to find a location with the same soil series and aspect as the other three sites (Figure 1). The three existing burn area sites are all in the Tallac soils series and have an east or southeast aspect. The control site was selected from all qualified areas due to its proximity to the other burn area sites as well as

Figure 1. Map of selected control site. The highlighted areas all have the same soil series and aspect as the survey sites in the burn area.
